FIELD INSPECTION

Project Name: Mountain Valley Pipeline Date:Thursday, January 31, 2019

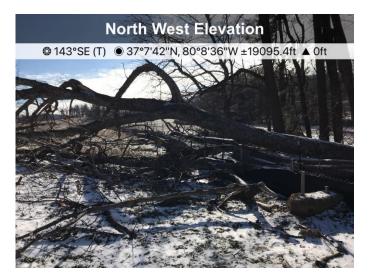
Fig. 2 Near St#12299 tree fallen on ECD waiting on NPS approval.
